ceramic implants

international magazine of ceramic implant technology

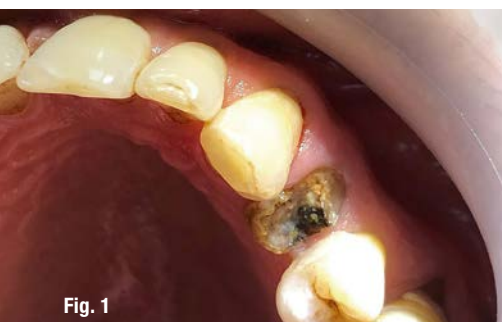
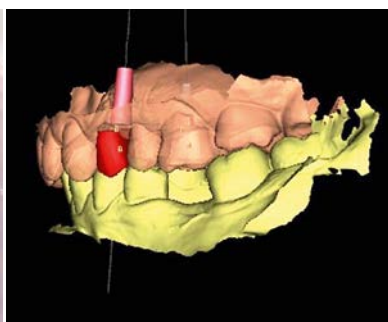
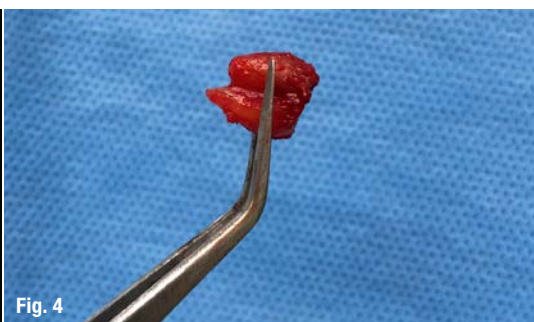
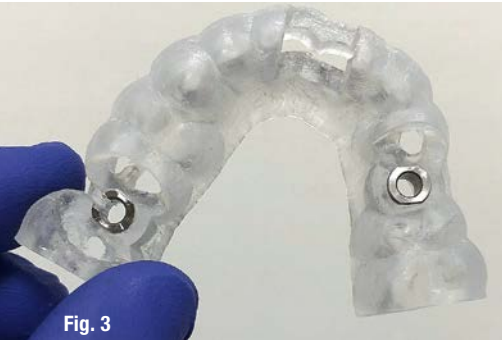
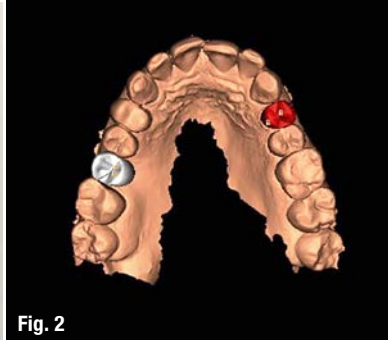
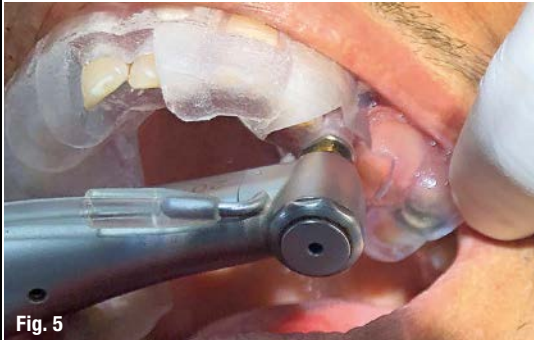
Fig. 1: Initial clinical situation. **Fig. 2:** Digital pre-planning of the surgery. **Fig. 3:** The final surgical guide. **Fig. 4:** The extracted tooth #24. **Fig. 5:** During the guided surgery treatment.

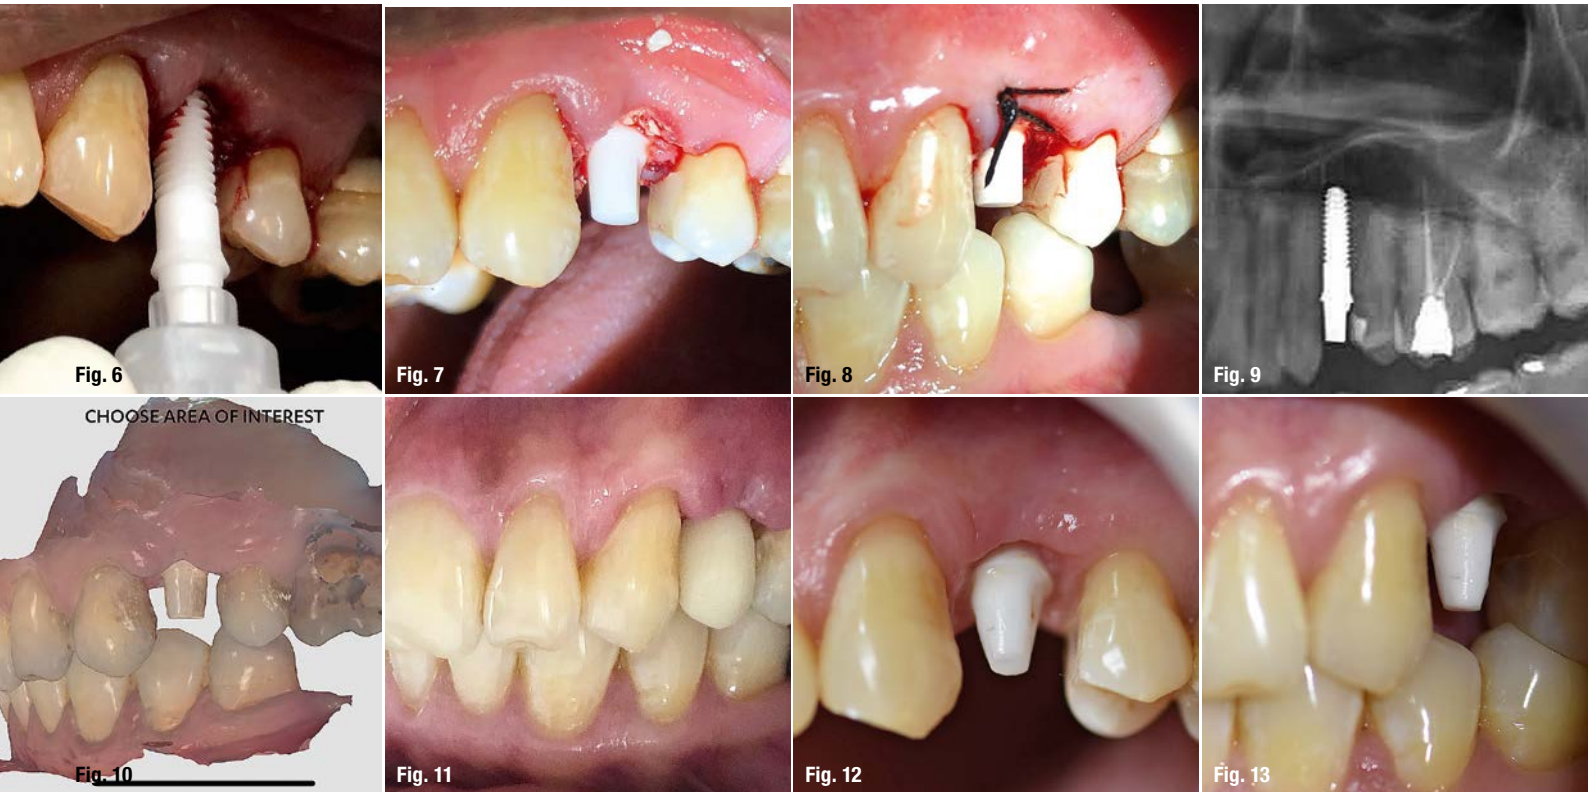
Fig. 6: Placement of the implant. **Fig. 7:** Bone grafting material placed around the implant body. **Fig. 8:** The horizontal mattress suture. **Fig. 9:** Radiograph taken immediately after surgery. **Fig. 10:** The optical scan after surgery. **Fig. 11:** The provisional restoration. **Figs. 12 & 13:** Tooth preparation.
